NASA Technical Memorandum 74077

Evaluation of Three
Thermal Protection Systems in
a Hypersonic High-Heating-Rate
Environment Induced by
an Elevon Deflected 30°

Allan H. Taylor, L. Robert Jackson, and Irving Weinstein

DECEMBER 1977

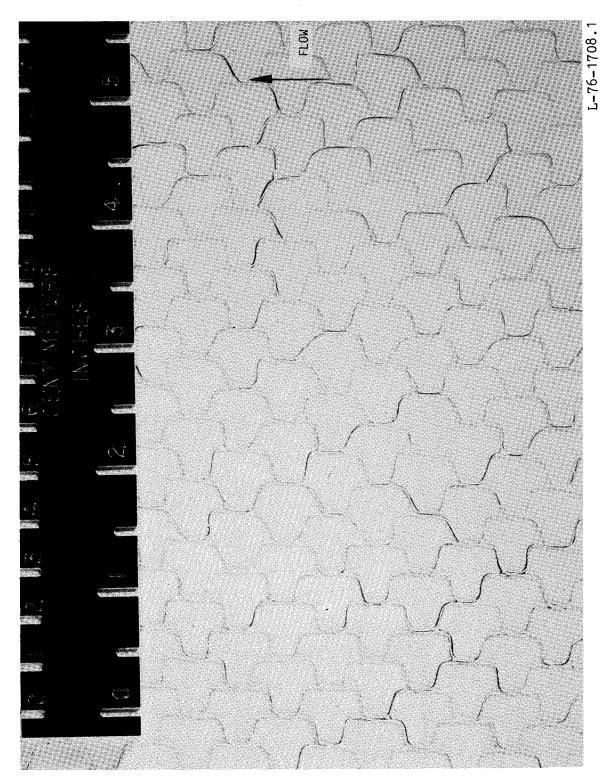
Figure 8.- Shrinkage of the honeycomb-filled insulator-ablator cells.

The honeycomb-reinforced insulator-ablator material as tested on the vehicle surface specimen is adequate for the low shear and heating rates experienced at low angles of incidence to the local flow. The cracking caused by the shrinkage of the material apparently does not degrade the capability of the thermal protection system. These cracks, however, may pose operational problems due to water entrapment.

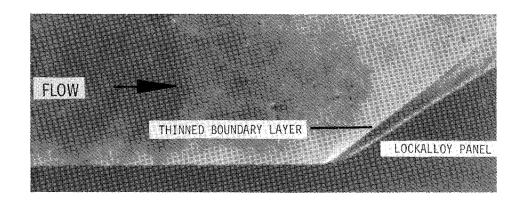
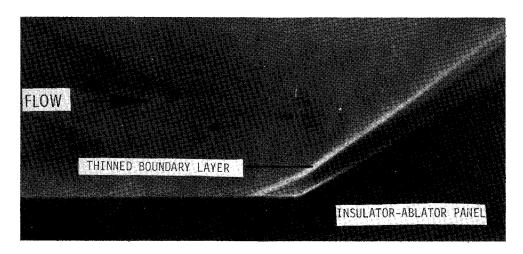
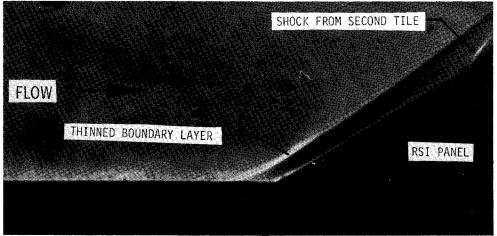
Figure 15.- Schlieren photographs of TPS tests.

Schlieren photographs of all three test specimens are shown in figure 15. The top photograph was taken during the first Lockalloy test. A thinned boundary layer is visible just above the intersection of the panel holder and the elevon in each case. No shock impingement or flow separation is evident. The boundary layer is noticeably thicker in the lower two photographs, possibly due to either mass addition to the flow from the surface-panel specimen mounted ahead of these two specimens or the increased surface roughness of the pyrolyzed insulator-ablator panel over the stainless surface panel.

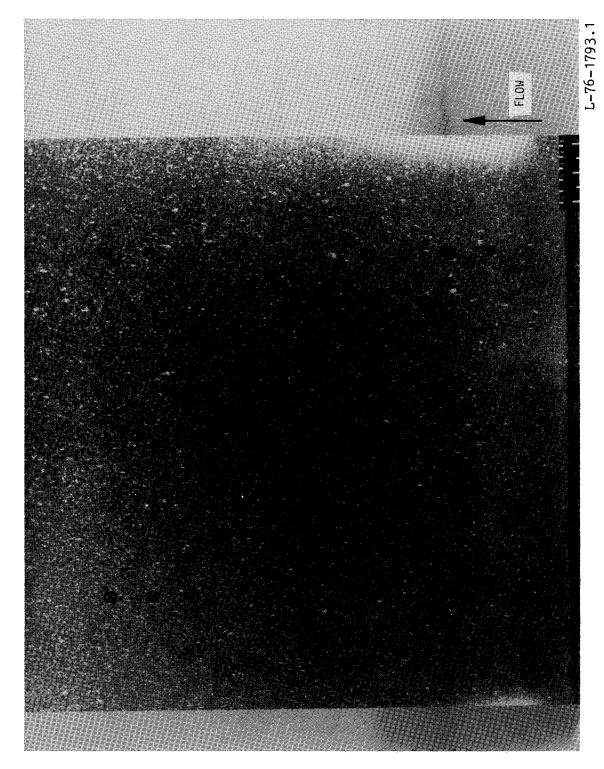
Figure 17.- Lockalloy specimen removed from panel holder.

The Lockalloy specimen was tested under the conditions outlined in the first three tests of table I. The temperature distributions along the center line of the specimen are shown in figure 16 for all three tests. The temperature distributions are compared with similar tests of a 1.3-cm-thick (0.5-in.) stainless-steel specimen (ref. 8). The model was fully inserted in the stream for about 10 seconds on each test. It can be seen in the area of highest heating rate that the temperature spike is quite visible for the stainless-steel panel of reference 8, whereas the high conductivity of the Lockalloy dissipates the heat pulse and holds a nearly uniform temperature throughout the panel in The maximum temperature difference on the face of the Lockalloy panel was never greater than 56 K (100° R). Figure 17 is a photograph of the Lockalloy specimen after the third test. The only discernible difference between this photograph and that taken prior to the testing is the local removal of small areas of paint caused by impacts from debris in the flow stream. At about 7.6 cm (3 in.) aft of the hinge line on both sides a small area of Lockalloy was completely bared due to the high local temperature and shear removing the paint. Bluing of the side skirt also suggests higher heating in this area.

The mass spectrograph analyses of the three swipe tests and the calibration swipe tests show no detectable concentrations of beryllium either before, between, or after the three tests of the Lockalloy panel in this environment. Since the only damage to the Lockalloy specimen was paint erosion due to particle impacts which are not typical for true flight environment, this panel was suitable for further testing and would require no refurbishment.

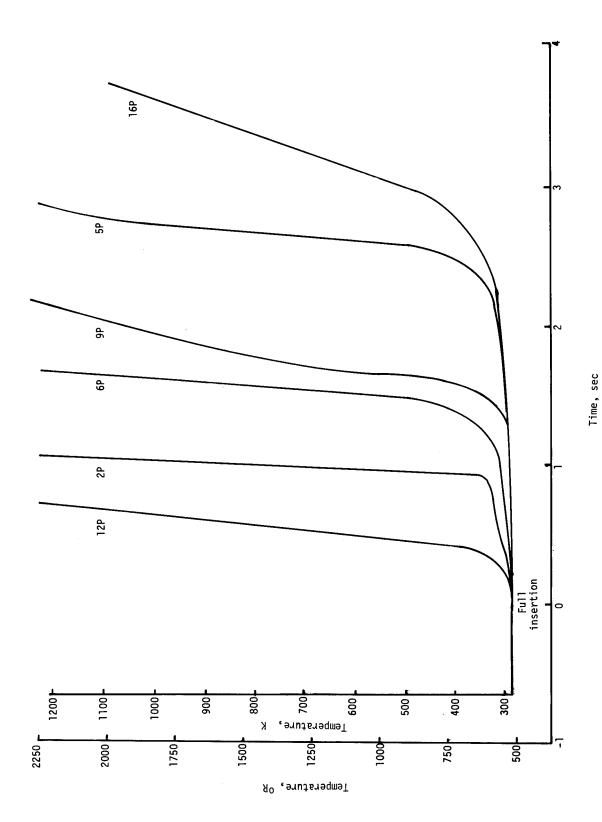
Figure 18.- Surface thermocouple readings during the insulator-ablator test.

Only one test (test 4 of table I) was made on the insulator-ablator specimen, and the test parameters are listed in table I. Shortly after insertion into the stream the surface thermocouples indicated an extremely rapid temperature rise (fig. 18). This indicates that the 0.3-cm-thick (0.12-in.) layer of insulator ablator over these thermocouples was removed by this time. The two surface thermocouples in the highest heating-rate area near the hinge line, locations 12P and 2P in figure 4 were apparently exposed first. The surface degradation followed rapidly up the elevon. All surface thermocouples were exposed in less than 3 seconds. This indicates that one-fifth of the 1.5-cmthick (0.6-in.) material was removed at these locations after this short exposure time. Backface thermocouple readings are presented in figure 19. backface (BF) temperature starts to rise after a 2-second exposure. After 8 seconds the temperature rise rate is quite high, over 56 K (100 $^{\circ}$ R) per sec-The lowest rates were observed on the thermocouples that remained in place ond. under the honeycomb material. These are designated 15BF and 13BF in figure 19.

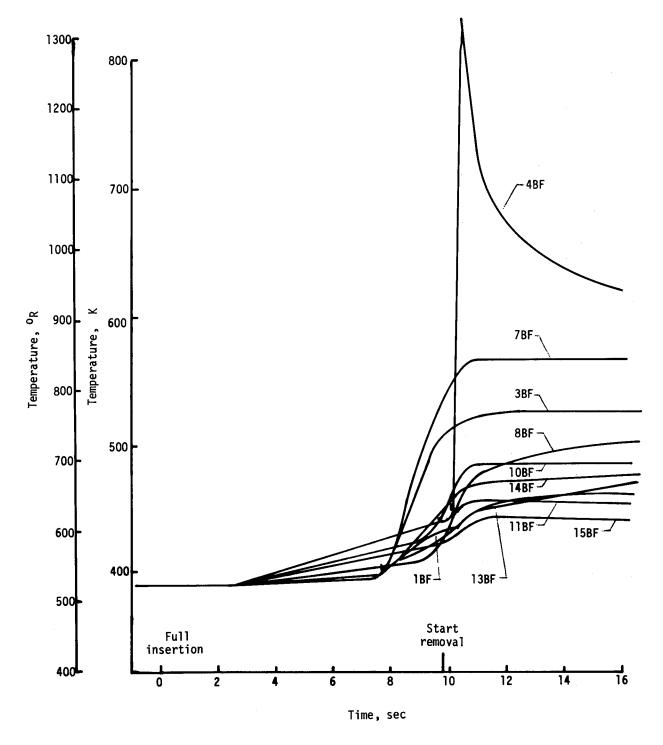
Figure 19.- Backface (BF) thermocouple readings during the insulator-ablator test.

The maximum acceptable operating temperature for aluminum is 422 K (760° R). (See ref. 10.) At this temperature aluminum has only 80 percent of its room-temperature properties, and the properties fall off quite rapidly beyond this temperature. As can be seen from figure 19, only the backface readings under the honeycomb-filled material were under 422 K (760° R) at the end of 10 seconds.

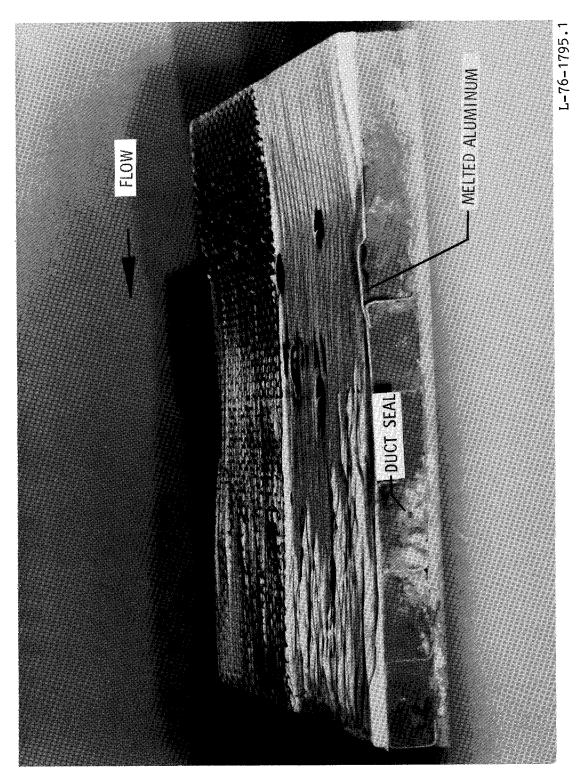
Figure 20.- Insulator-ablator specimen after testing.

The mode of failure of the insulator ablator is also unique. The material was expected to ablate under high-heat loads; however, in this test the virgin material apparently sheared away before reaching ablation temperatures. Figure 20 is a photograph of the panel following the test. A large quantity of the material has been removed and incipient melting of the aluminum substructure is evident in several locations. The photograph in figure 21 is a closeup view of the trailing edge of the panel showing the relative performance of the two insulator-ablator materials. Virgin material is evident in both the striated and honeycomb-filled materials. The striated material shows the characteristic grooving along the slits which continue aft into the unstriated thickness. The honeycomb-reinforced material shows little charring and is pyrolyzed near the leading-edge hinge line. Less than 2.5 cm (1 in.) from the leading edge the honeycomb cells show evidence of severe charring and the insulator still exhibits pyrolization. However, further up the panel the virgin material is again visible, surrounded by the severely charred honeycomb core. The charring of honeycomb core is not as severe at the aft end as it is near the leading edge. Also, the core improves the shear resistance of the material.

The insulator-ablator material failed at the elevon test conditions of 47.9 kPa (1000 psf), and some damage was sustained on the reusable-surface-insulation (RSI) specimen. The insulator-ablator material did not ablate as predicted. The virgin material was quickly removed by wind shear, thus exposing the aluminum substructure. The honeycomb-filled insulator ablator exhibited slightly better shear resistance, but it also was severely degraded. It should be noted that the insulator-ablator material was not considered applicable for these high-heating-rate applications. However, areas of severe heating are not easily predicted. For these extreme test conditions, the fail-safe ablation concept of the material was shown to be invalid. The material eroded prior to reaching ablation temperature.

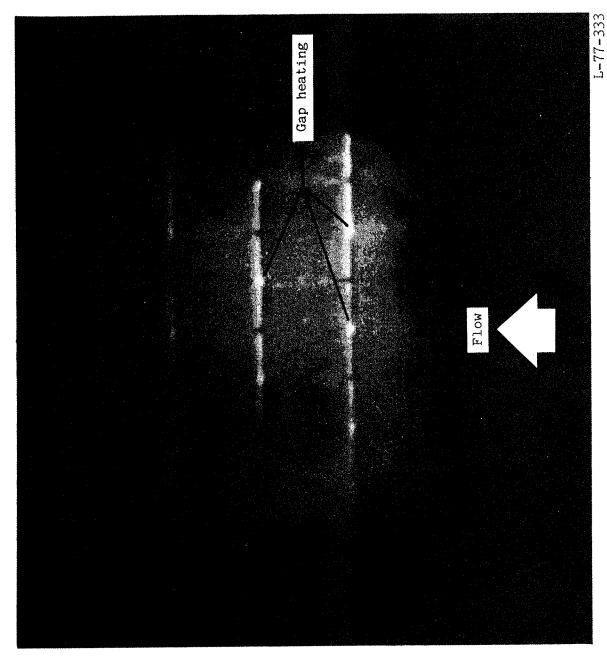
Figure 23.- The RSI specimen in test stream showing areas of heating.

The silica RSI specimen was subjected to an environment similar to that of the Lockalloy and insulator ablator. Figure 23 is a photograph of the specimen in the test stream during the test. The light areas indicate that the surface of the RSI is heated. The brightest areas are caused by the higher temperatures induced by flow in the gaps where the tile walls are not free to cool by radiation. The gap flow is impinging on the leading edge of the downstream tile because of the staggered joints. This impingement causes higher local heating as indicated by the brightest areas in line with the gaps.

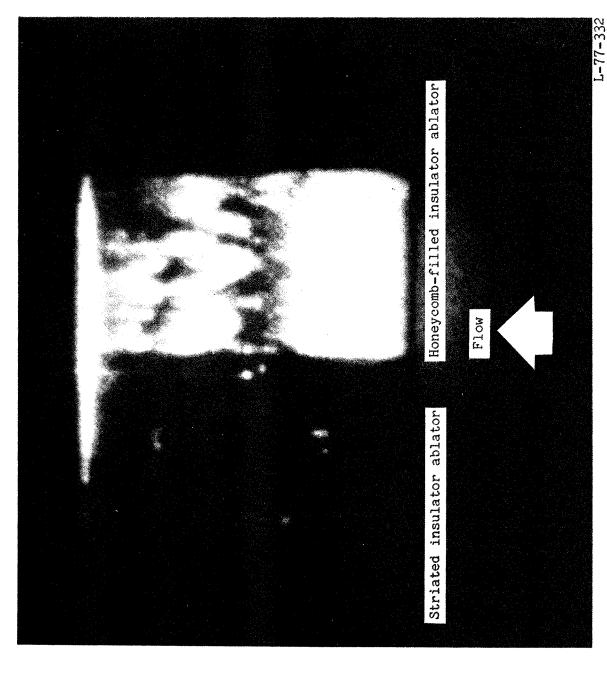
Figure 22.- Insulator-ablator specimen in test stream showing areas of heating.

Figure 22 is a photograph of the specimen in the test stream approximately halfway through the test. The bright areas indicate high-temperature locations. In these locations the material has reached radiation equilibrium temperature. However, most of the area is dark, indicating that the material has not reached radiation equilibrium temperature. This can be caused by material erosion most probably initiated by the high shear forces created in the flow before the material could be heated to radiation equilibrium temperature. This is the apparent cause since a significant amount of the remaining insulator ablator is virgin unpyrolized material.

Figure 22 also shows the heating at the top edge which is more pronounced near the center of the panel. The heating rate in the corners was apparently less than that near the center, and erosion of the material at the trailing edge is more severe near the center.

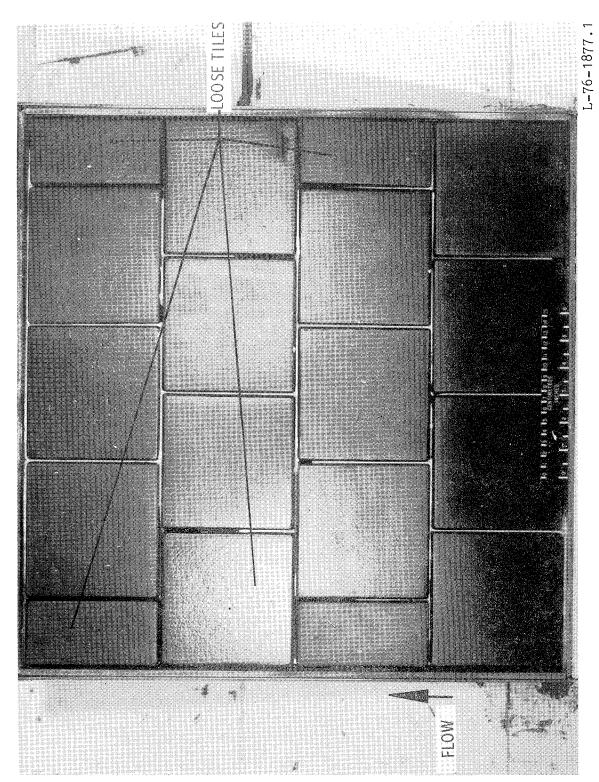
Figure 2^{μ} . Damage of RSI specimen after testing.

A posttest photograph of the model is shown in figure 24. Some minor pitting of the RSI coating is noted. This is assumed to be the result of debris in the flow stream, which would not be representative of real flight conditions. Also, some inter-tile batting has been removed, and the remaining peripheral and inter-tile batting is visible. Inspection of the panel after testing revealed that four tiles were loose. The backface thermocouple readings did not rise appreciably during the test.

Four RSI tiles were partially debonded after testing and considerable joint packing was lost, thus indicating a need to develop a better packing and edge seal to avoid gap flow. This gap flow may cause thermal strains in the substrate which in itself could promote the bond failure. The debonding of the RSI tiles did not degrade its thermal performance. Some pitting of the coating of the tiles was precipitated by particle impacts.

The RSI material effectively insulated the aluminum panel from the deflected elevon environment. However, the four loose tiles would require some maintenance and the batting between the tiles would require either replacement, especially in the streamwise direction, or a better means of retention.
